# ENSV Inspection Transmittal Summary Report

# REPORT OF RCRA FOLLOW-UP INSPECTION

## **RECYCLETRONICS**

1220 Steuben Street  
Sioux City, Iowa 51105  
(712) 224-3158

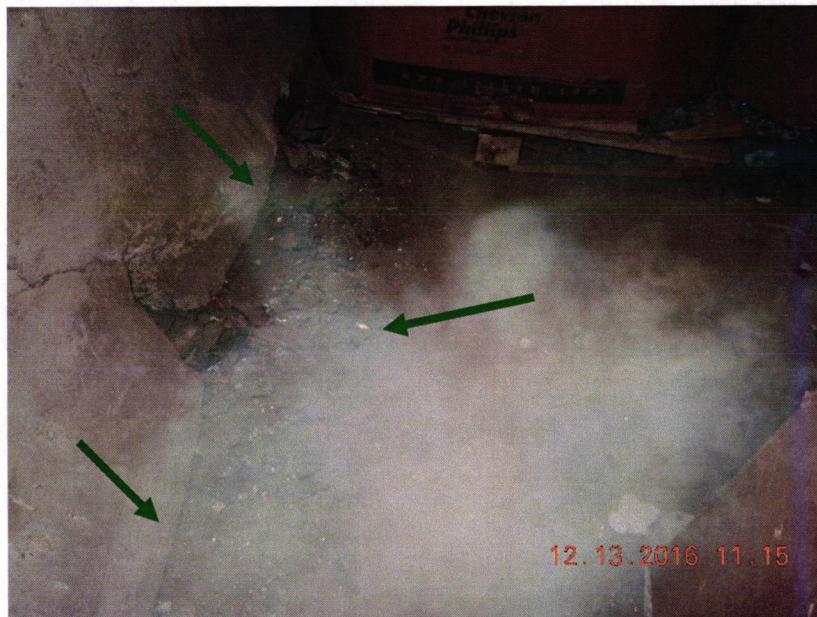
Photo of broken glass (clear and dark) located on the concrete floor in the Glass Area (Warehouse). Photo taken facing north.

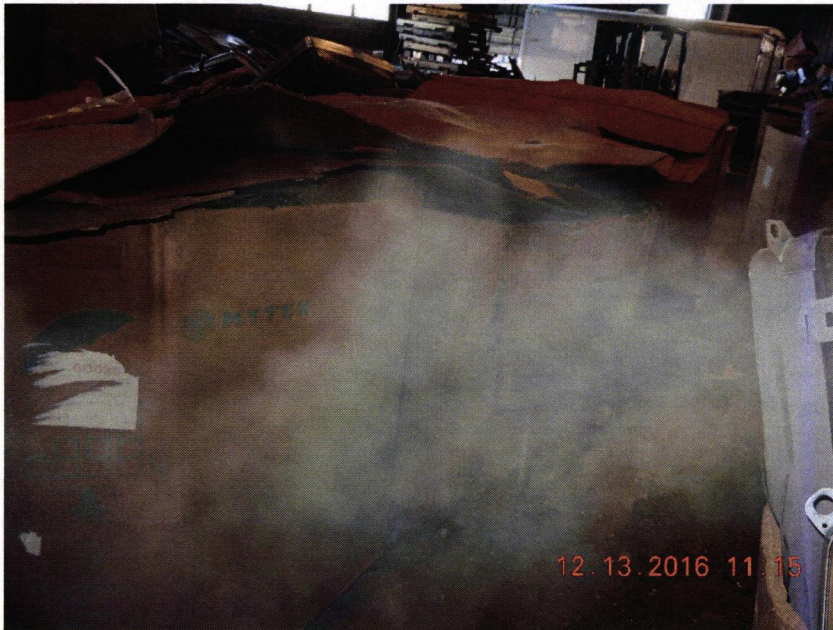
Photo of four 1-cubic yard containers of broken unleaded panel class located at the Glass Area (Warehouse). Photo taken facing northeast.

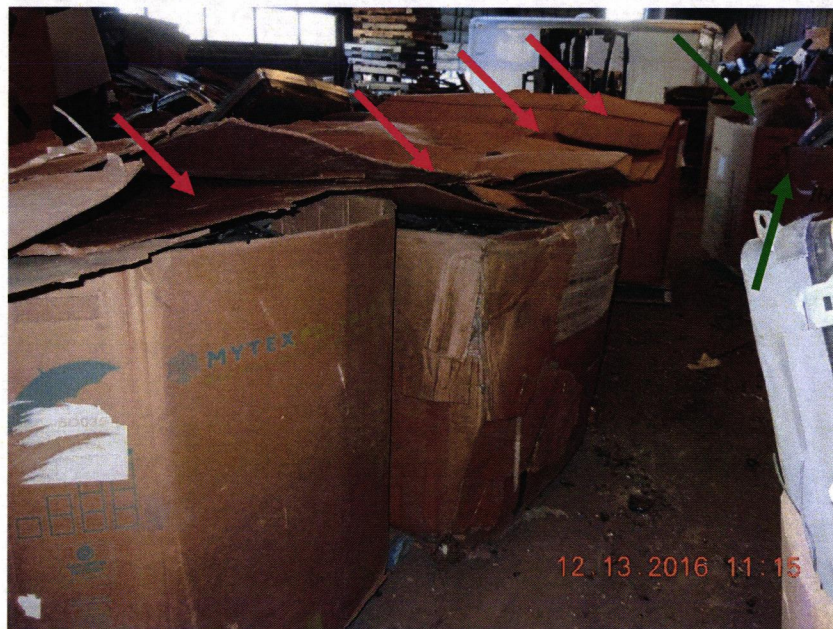
Same containers in Photo 3 (red arrows) and two full 1-cubic yard cardboard containers of broken/intact CRTs labeled with the words "Used Cathode Ray Tubes - Contains Lead Glass" and "Do Not Mix with Other Glass Material" (right - green arrows) located at the Glass Area (Warehouse). Photo taken facing northeast.

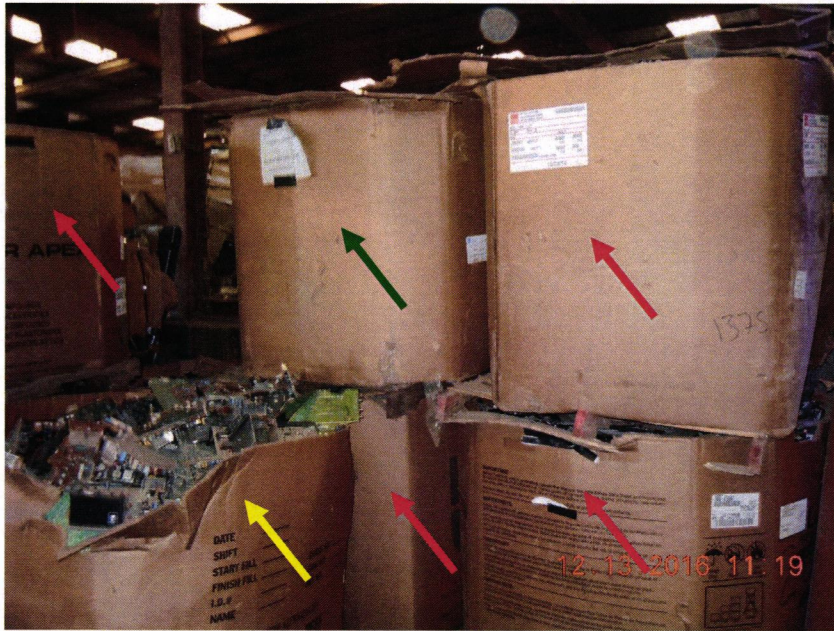
Photo of one cubic yard container of broken lead funnel glass (broken funnel glass) labeled with the words “Used Cathode Ray Tubes - Contains Lead Glass” (green arrow), one cubic yard container of circuit boards (yellow arrow), and four cubic yard containers of broken unleaded panel glass (red arrows) located at the Warehouse. Photo taken facing southeast.

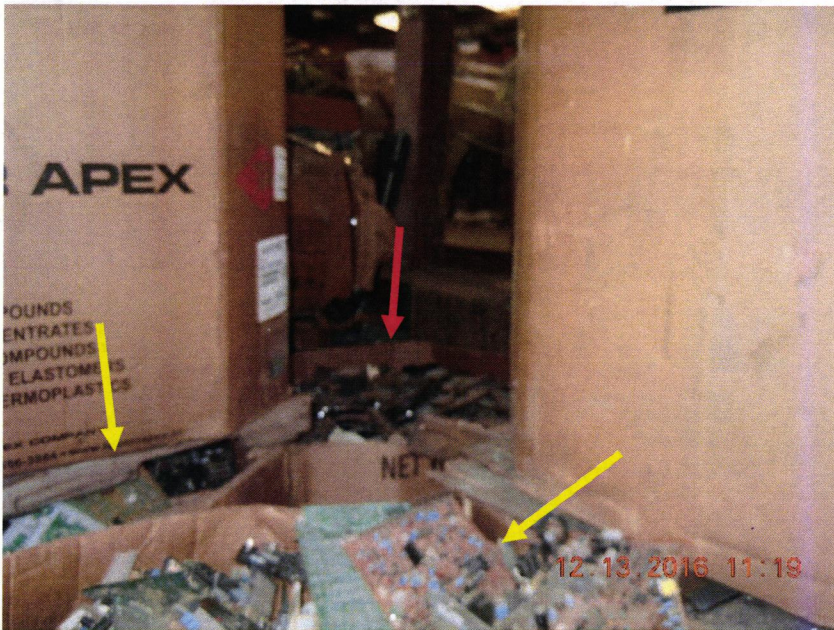
Photo of two 1-cubic yard containers of circuit boards (yellow arrows) and one cubic yard container of broken unleaded panel glass (red arrow) located at the Warehouse. Photo taken facing southeast.

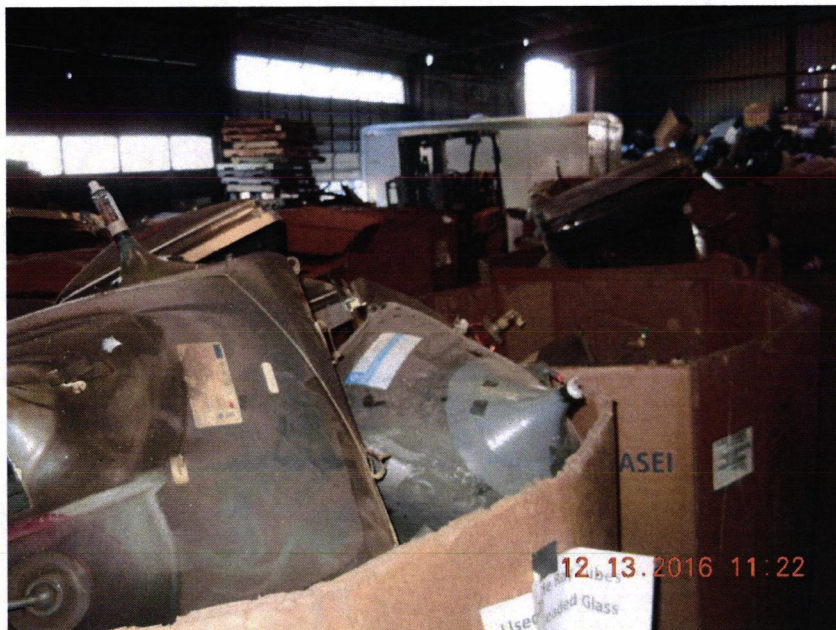
Photo of three full 1-cubic yard cardboard containers of broken/intact CRTs labeled with the words "Used Cathode Ray Tubes - Contains Lead Glass" and "Do Not Mix with Other Glass Material" located at the Glass Area (Warehouse). Photo taken facing northeast.

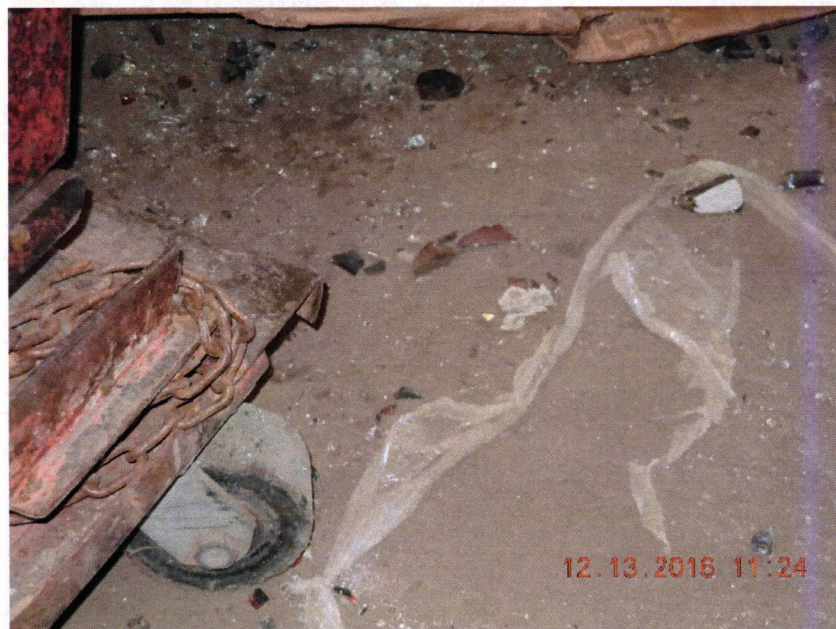
Photo of broken glass (clear and dark) located on the concrete floor in the Glass Area (Warehouse). Photo taken facing northeast.

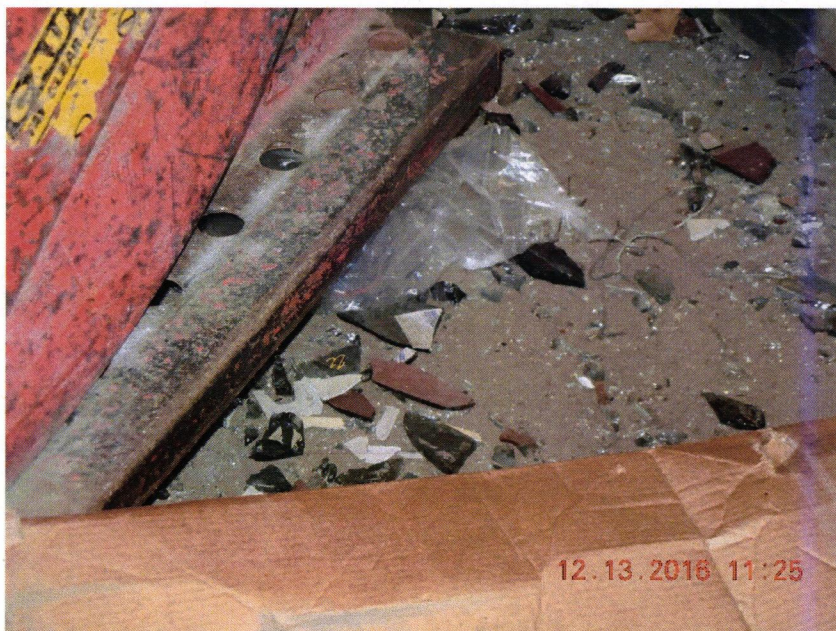
Photo of broken glass (clear and dark)  
located on the concrete floor in the  
Glass Area (Warehouse). Photo taken  
facing northeast.

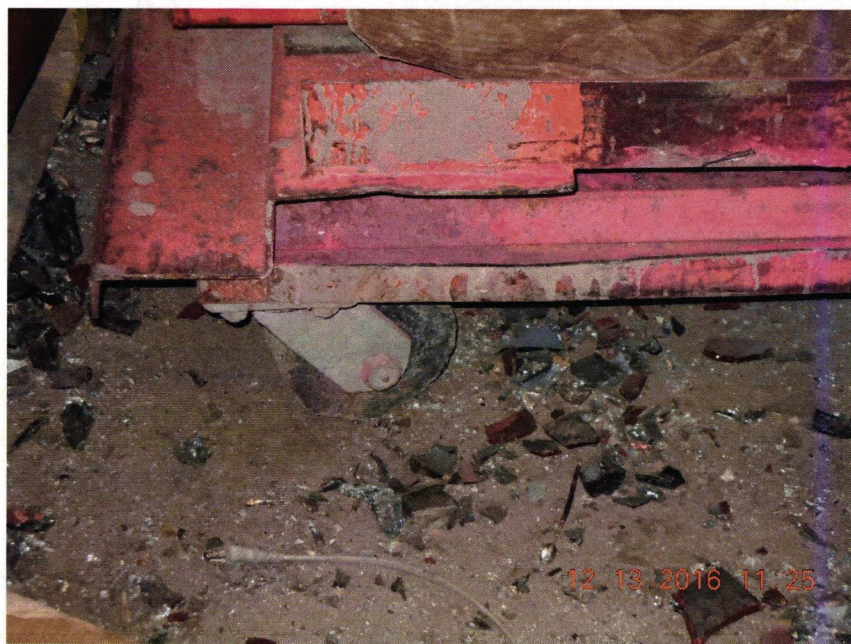
Photo of broken glass (clear and dark)  
located on the concrete floor in the  
Glass Area (Warehouse). Photo taken  
facing east.

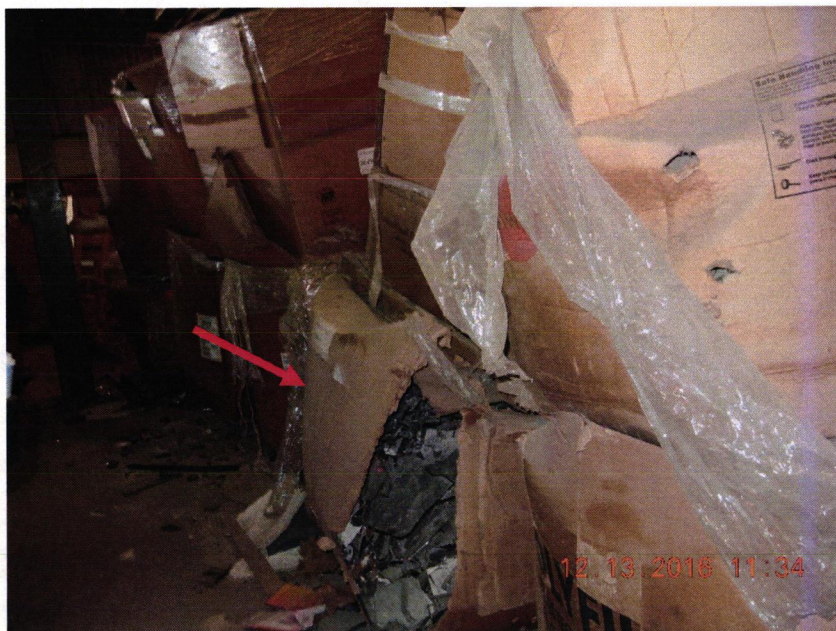
Photo of 10 one-cubic yard cardboard containers of broken lead funnel glass, broken unleaded panel glass, and non-processed electronics located at the Warehouse. Open and unlabeled one-cubic yard container of unleaded panel glass (red arrow). Photo taken facing east.

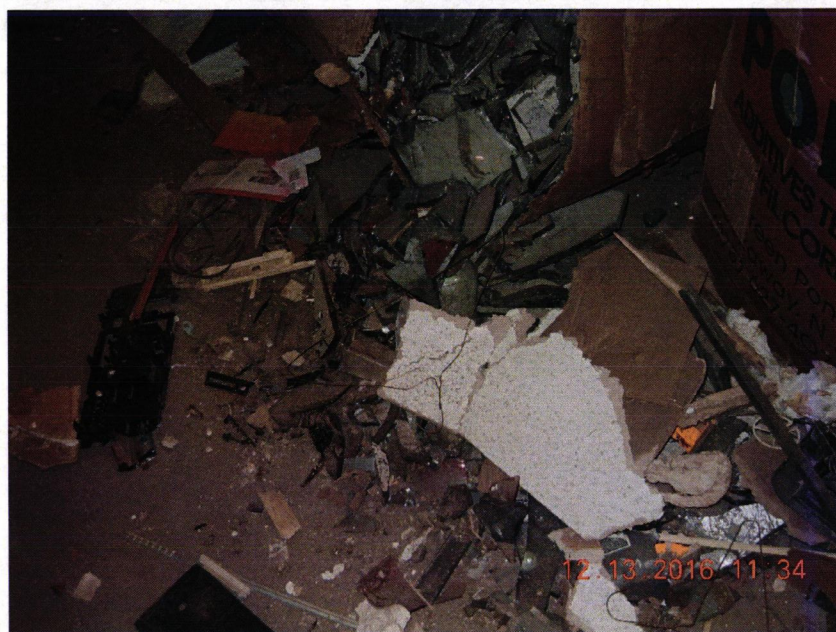
Photo of one open cubic yard container of unleaded panel glass (same container in Photo 13), broken glass (clear and dark) on the floor, and debris located at the Warehouse. Photo taken facing east.

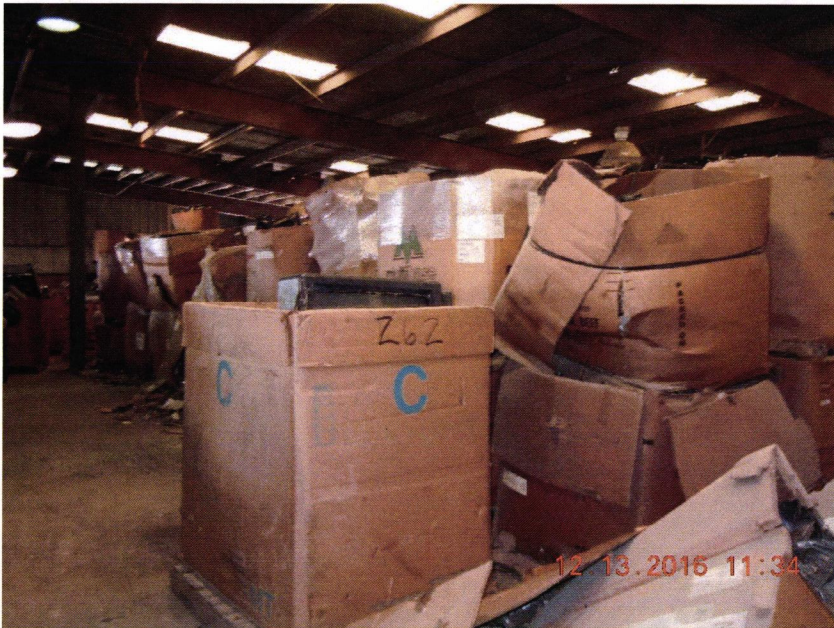
Photo of 22 one-cubic yard cardboard containers of broken lead funnel glass, broken unleaded panel glass, and non-processed electronics located at the Warehouse. Photo taken facing west.

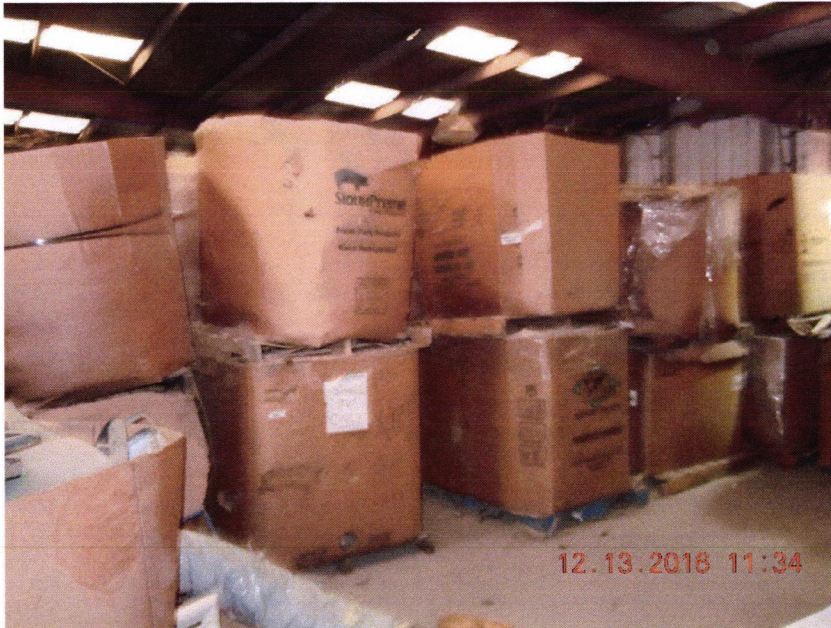
Photo of 12 one-cubic yard cardboard containers of broken lead funnel glass, broken unleaded panel glass, and non-processed electronics located at the Warehouse. Photo taken facing south.

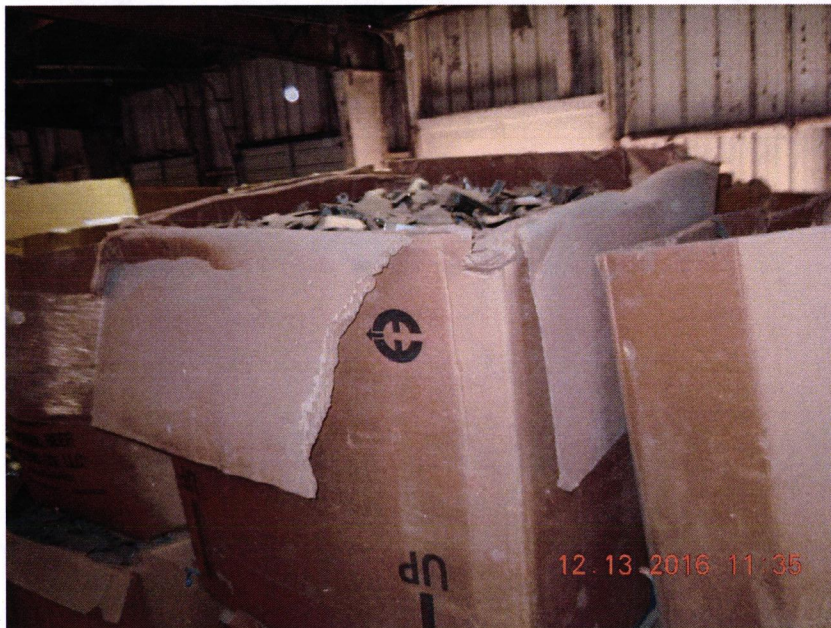
Photo of 4 one-cubic yard cardboard containers of broken unleaded panel glass located at the Warehouse. Photo taken facing south.

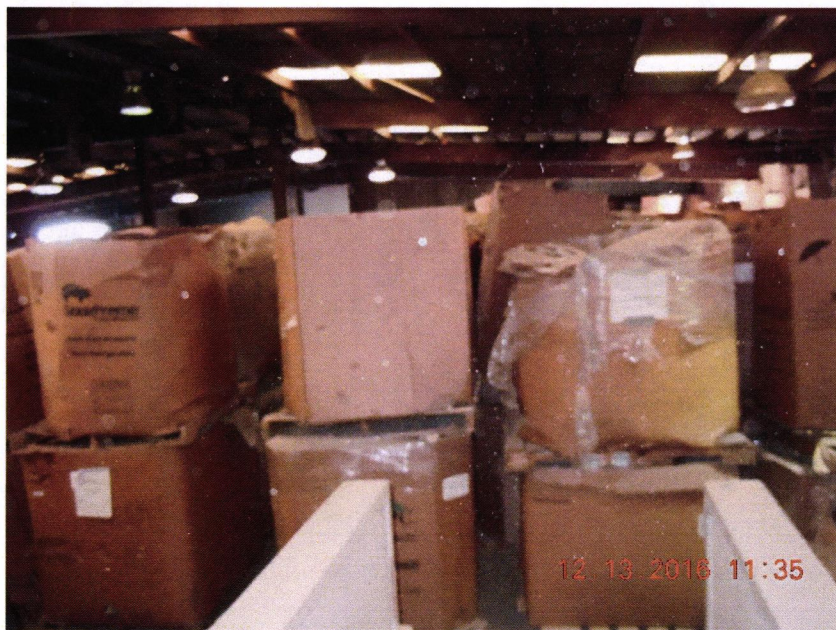
Photo of four rows of one-cubic yard cardboard containers (double stacked) of broken lead funnel glass, broken unleaded panel glass, and non-processed electronics located at the Warehouse. Photo taken facing east.

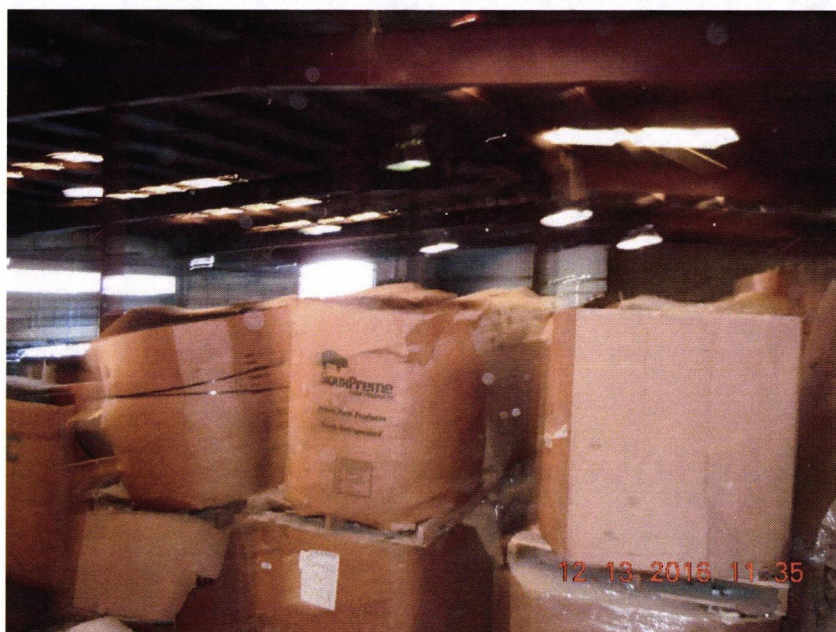
Photo of three rows of one-cubic yard cardboard containers (double stacked) of broken lead funnel glass, broken unleaded panel glass, and non-processed electronics located at the Warehouse. Photo taken facing east.

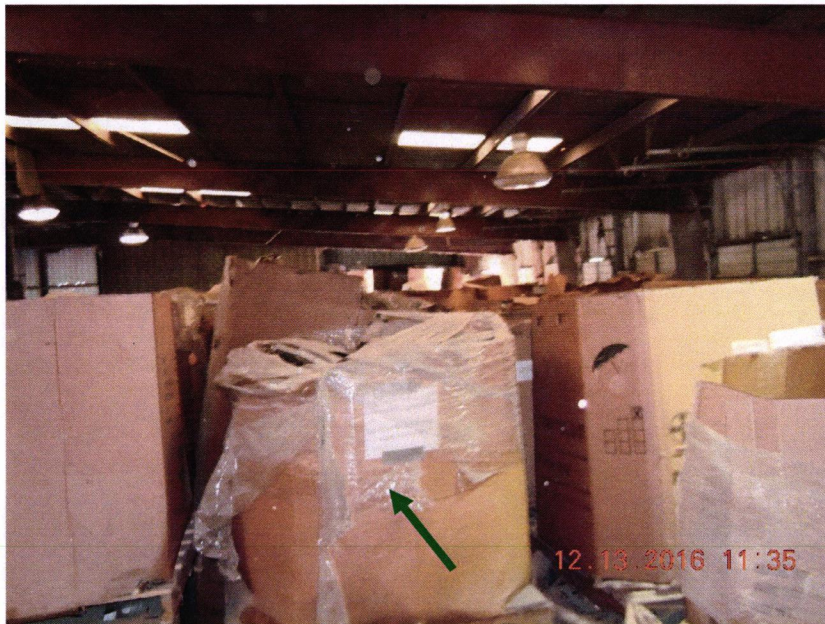
Photo of three rows of one-cubic yard cardboard containers (double stacked) of broken lead funnel glass, broken unleaded panel glass, and non-processed electronics located at the Warehouse. One full one-cubic yard cardboard container of broken lead funnel glass labeled with the words “Used Cathode Ray Tubes - Contains Lead Glass” and “Do Not Mix with Other Glass Material” (green arrow). Photo taken facing east.

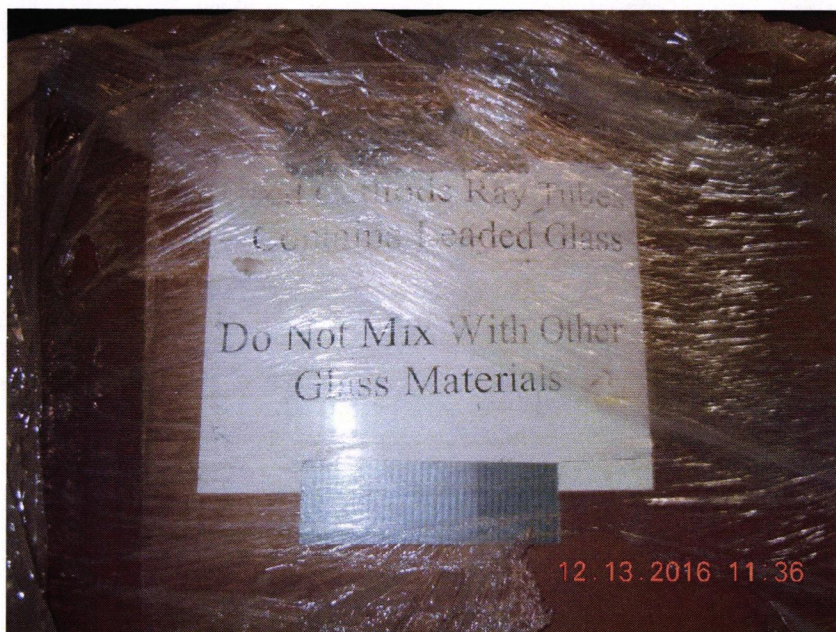
Photo of one full one-cubic yard cardboard container of broken lead funnel glass labeled with the words "Used Cathode Ray Tubes - Contains Lead Glass" and "Do Not Mix with Other Glass Material" located at the Warehouse. Photo taken facing south.

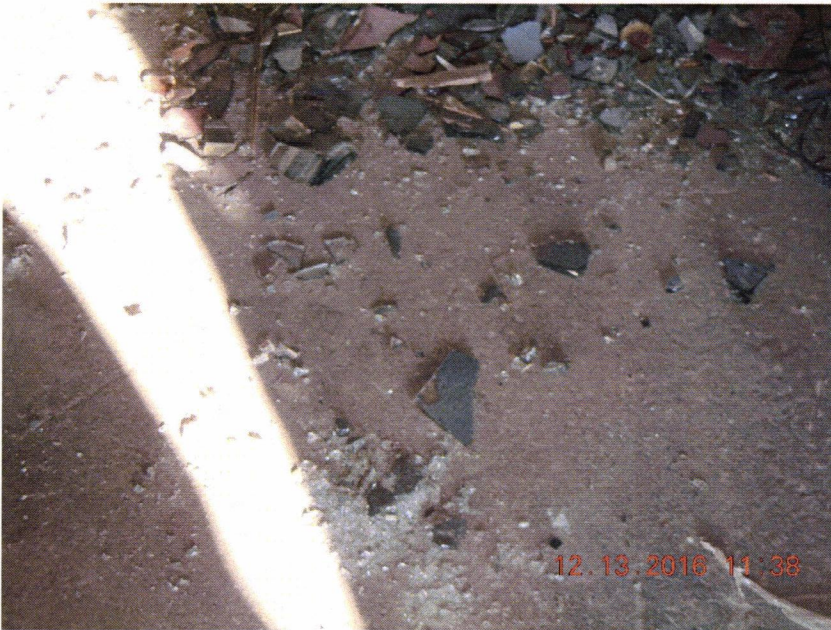
Photo of broken glass (clear and dark) on concrete floor in the Glass Area (Warehouse). Photo taken facing south.

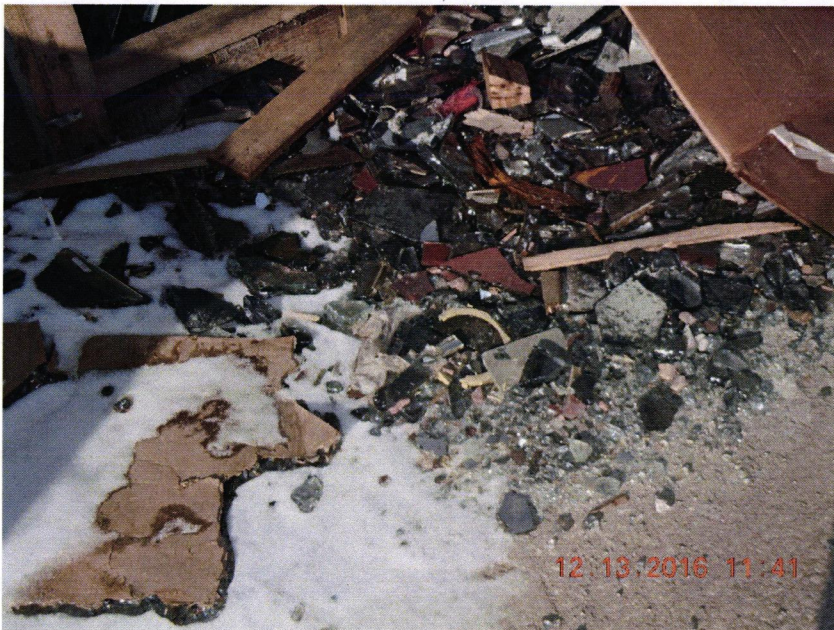
Photo of broken glass (clear and dark) located on the concrete floor at the Dock. Photo taken facing southeast.

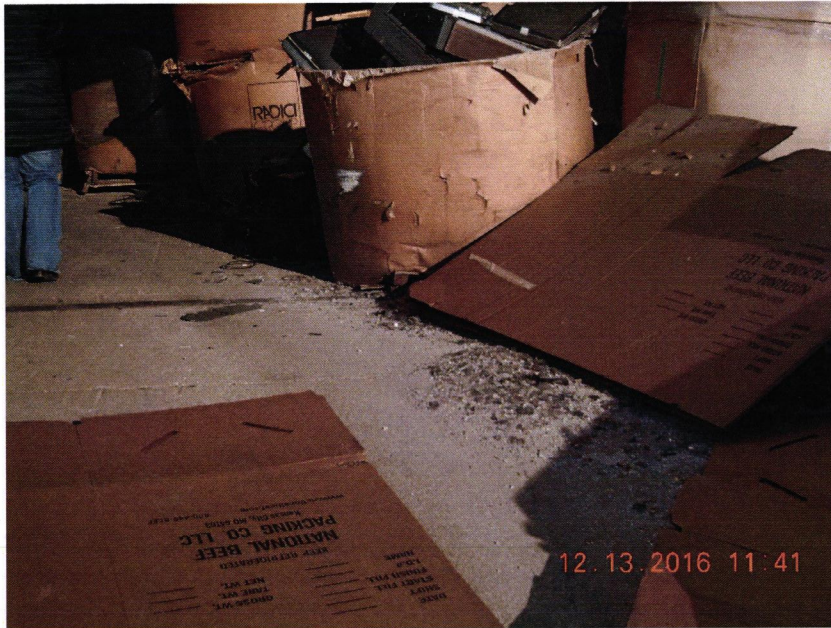
Photo of broken glass (clear and dark) on concrete floor and two 1-cubic yard cardboard containers of non-processed electronics located at the Dock. Photo taken facing north.

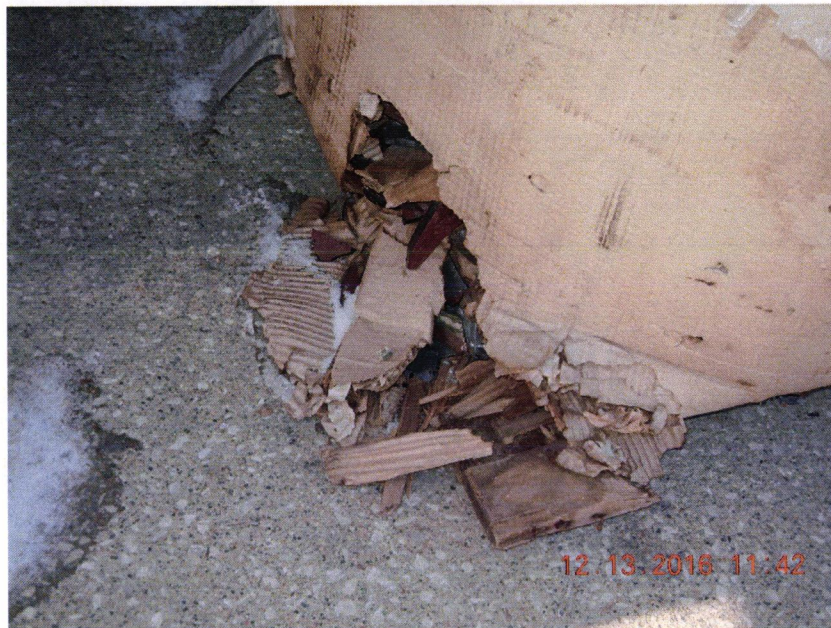
- Out of the 96 one-cubic yard containers, I observed one full one-cubic yard cardboard container storing broken clear and dark glass (photo 34). The container was unlabeled and it had a hole (an estimate of 10-inches wide and one-foot long) at the bottom. The container appeared to release at least six 5 to 6-inch shards of broken clear and dark glass on the concrete dock. I asked Mr. Gutierrez if the container stored broken lead funnel glass and unleaded panel glass. Mr. Gutierrez stated that the container stored unleaded panel glass only.

Photo of one 1-cubic yard cardboard container of broken glass (one 1-foot long hole at the bottom - released at least six 5 to 6-inch shards of broken clear and dark glass on the concrete dock) located at the Dock. Photo taken facing north.

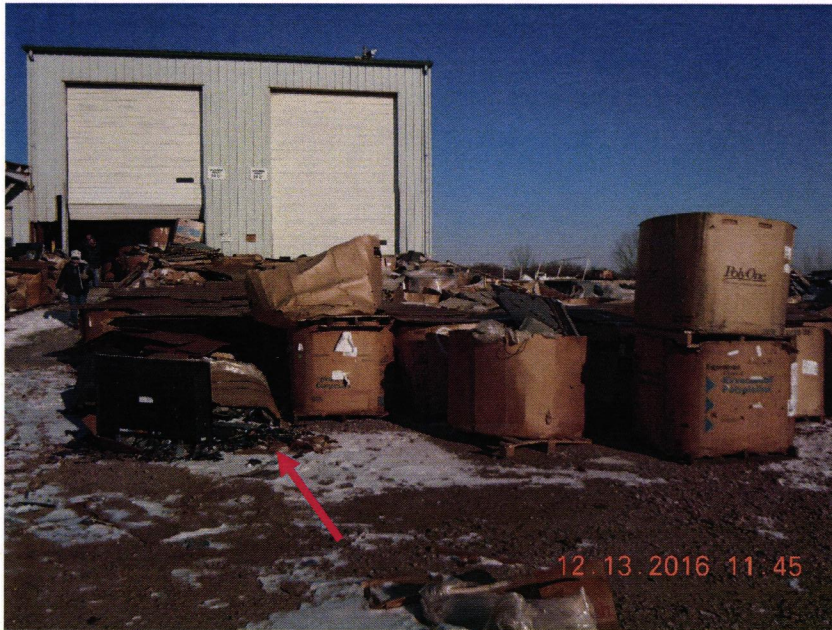
Photo of 96 full one-cubic yard cardboard containers of broken lead funnel glass, broken unleaded panel glass, and electronics (TVs, computer monitors, radios, etc.) and one 2 by 6-foot long release of dark glass on the dirt ground (red arrow) located at the Dock. Photo taken facing north.

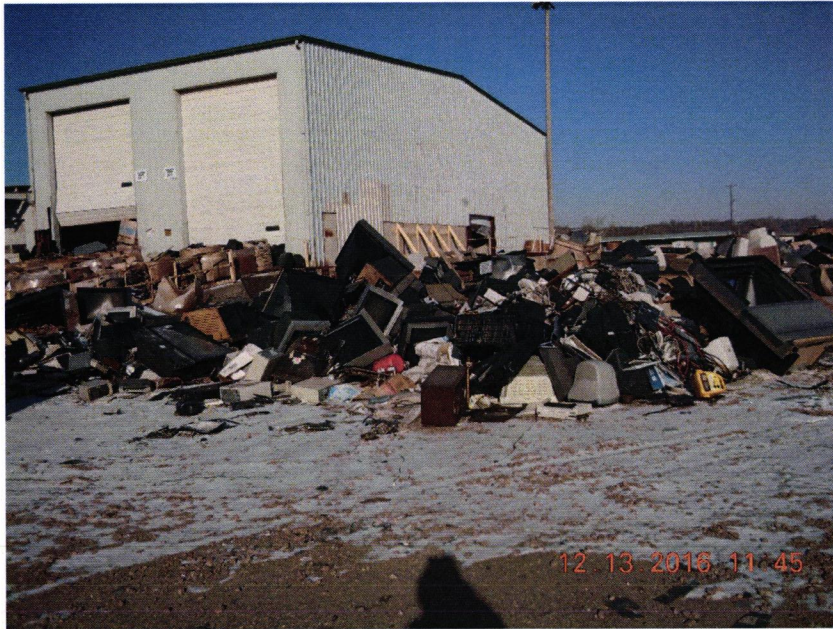
- One 100-foot long pile (a minimum at least three feet high) of non-flat screen televisions and computer monitors (photos 37-57). The pile contained a minimum of 50 one-cubic yard containers of crushed glass (clear and dark), intact CRTs, broken CRTs, and electronics. Due to the lack of aisle space and safety considerations, I could not visually inspect the condition and contents of each container. Mr. Gutierrez stated that he did not know the exact date of accumulation of the pile and it possibly had been on-site for four to five weeks.

Photo of one 100-foot long pile of TVs, flat screens, and computer monitors located east of the Dock (The pile contained a minimum of 50 one-cubic yard containers of crushed glass, intact CRTs, broken CRTs, and used electronics) and 96 full one-cubic yard cardboard containers of broken lead funnel glass, broken unleaded panel glass, and electronics located on the Dock. Photo taken facing northwest.

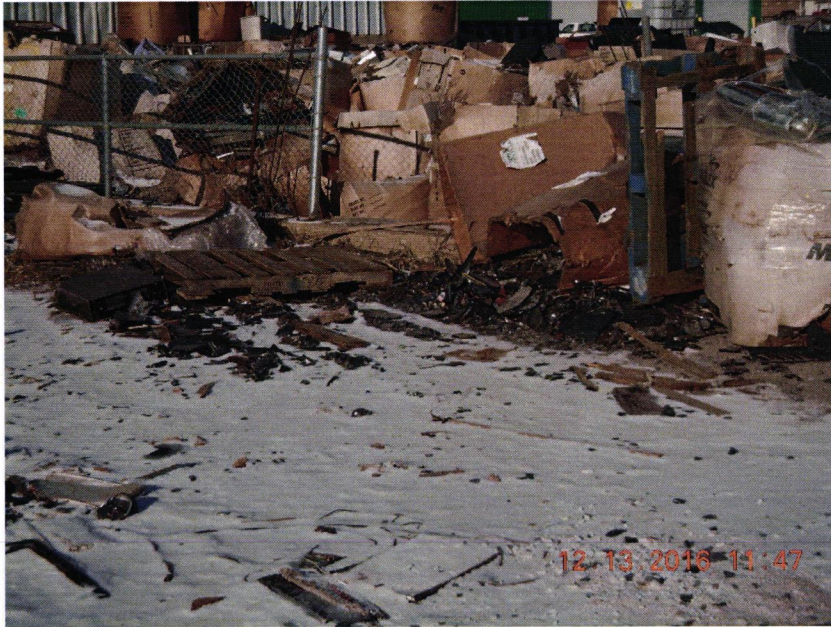
Photo 41      Michael J. Martin *MJM*

- In the pile, I observed one 12 by 12-foot long release of broken clear and dark glass on the dirt ground (photos 41 and 47).
  - In the pile, I observed 60 to 75 silver-tip fluorescent lamps (four and six-foot-long) (photos 48-55). The lamps appeared to be spent and 75% of the lamps were broken. The broken lamp pieces were accumulated on the dirt ground. Mr. Gutierrez stated that lamps had been on-site for two to four weeks and they were dropped off by SW Recycling (Wilmer, Minnesota). I asked Mr. Gutierrez if the Recycletronics recycles spent fluorescent lamps. Mr. Gutierrez stated, "No." I asked Mr. Gutierrez if the lamps were hazardous waste. Mr. Gutierrez stated that he did not know. I asked Mr. Gutierrez if he had conduct a hazardous waste determination on the lamps. Mr. Gutierrez stated, "No."

Photo of one 12 by 12-foot long release  
of broken glass (clear and dark) glass on  
the ground (within the pile in Photo 37).  
Photo taken facing northwest.

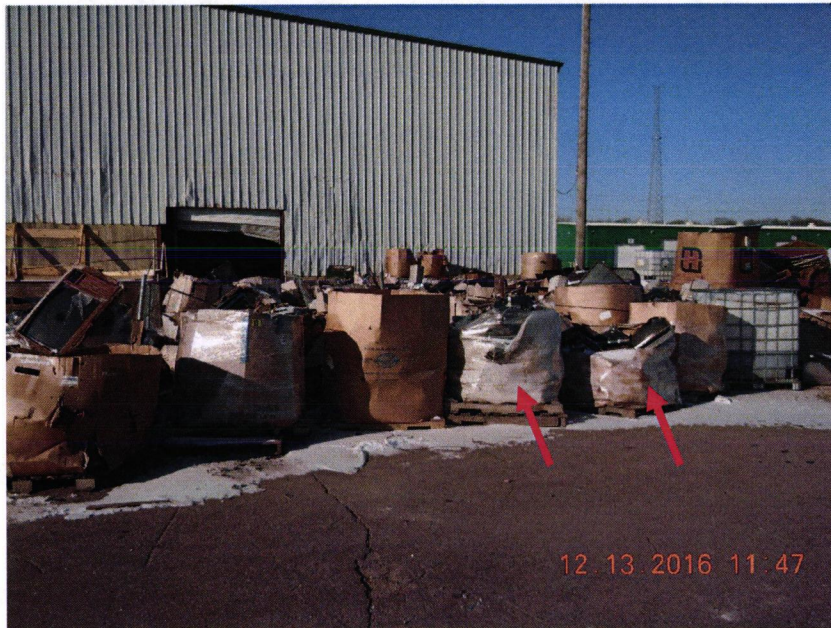
Photo 42      Michael J. Martin *MJM*

Same image as Photo 37 and two 1-  
cubic yard containers of broken CRTs  
(red arrows – see photos 43-46). Photo  
taken facing west.

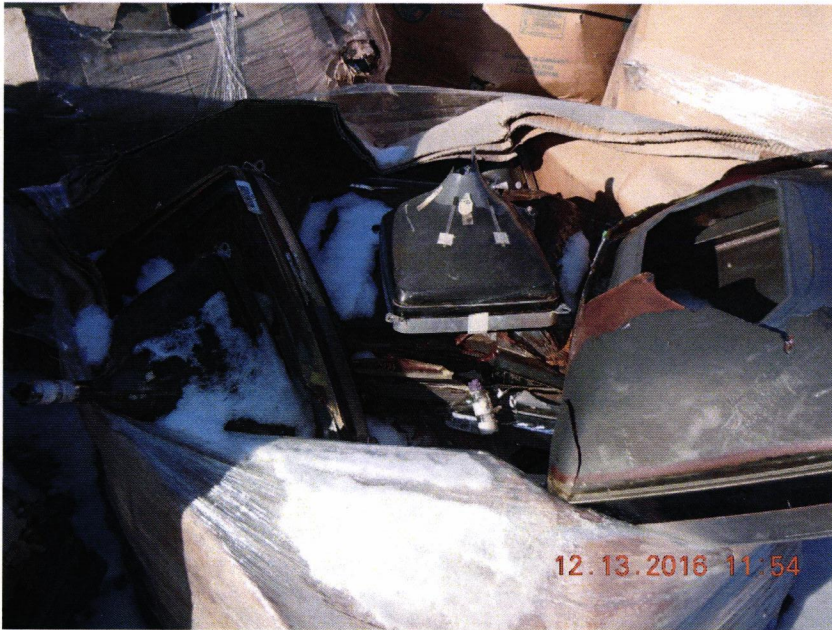
- In the pile, I observed two full one-cubic yard containers of broken CRTs (photos 43-46). These containers were open and unlabeled. Mr. Rochester stated that that two containers stored broken CRTs.

Photo of one full one-cubic yard container of broken CRTs (open and non-labeled) (within the pile in Photo 37). Photo taken facing west.

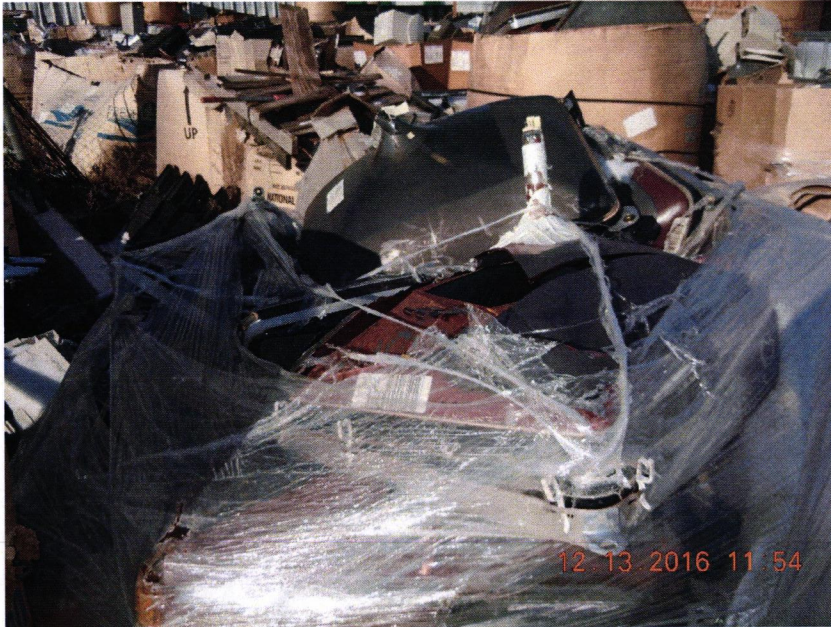
Photo of one full one-cubic yard container of broken CRTs (open and non-labeled) (within the pile in Photo 37). Photo taken facing north.
